Mooney Mite Series M-13  
Service Bulletin No. 14

MOONEY AIRCRAFT, INC.  
M-18 SERVICE LETTER NO. 15

M-18 SERVICE LETTER NO. 16

DATE: OCTOBER 24, 1959  
SUBJECT: REAR BULKHEAD REINFORCEMENT  
MODELS AFFECTED: NOTED  
TIME OF COMPLIANCE: IN CONJUNCTION WITH MOONEY M-18 SERVICE LETTER NO. 16

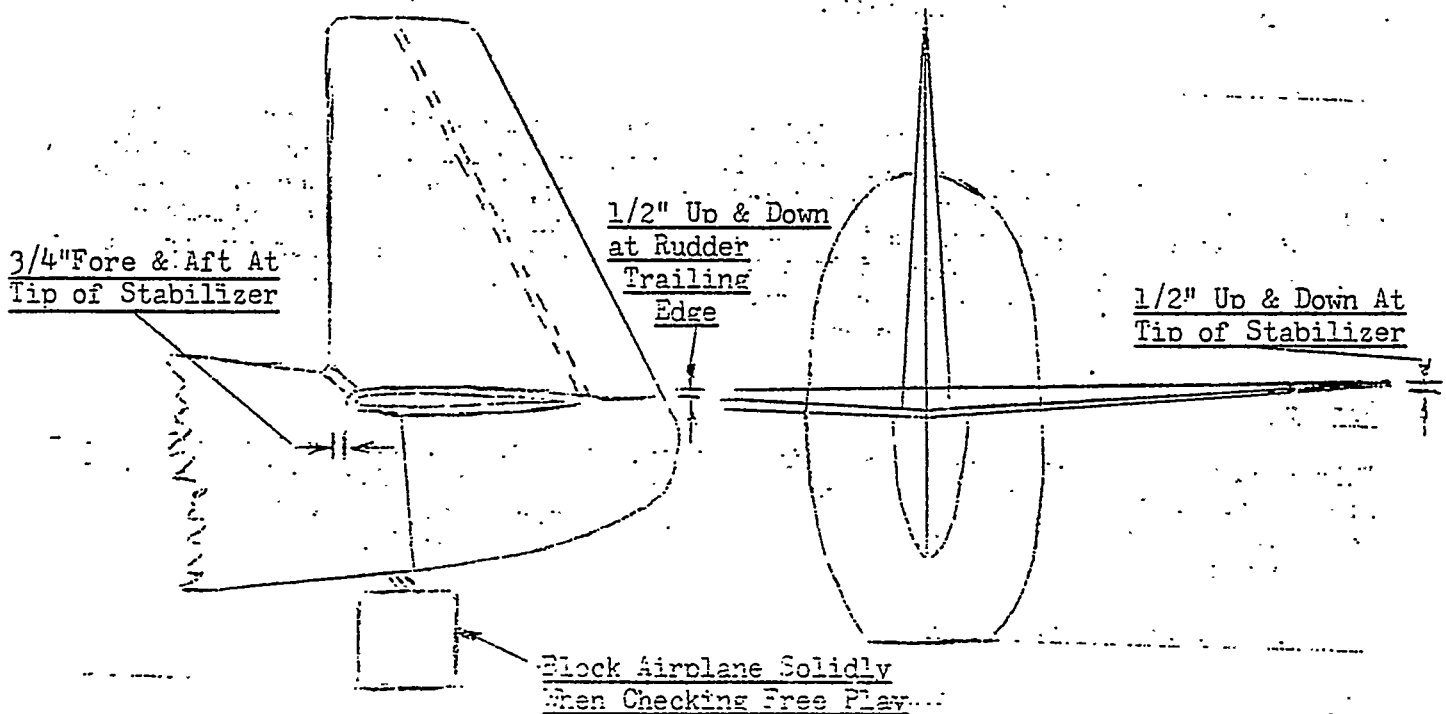
The following sketch illustrates the maximum allowable free play at the specified points.

When checking stabilizer tip free play, either fore and aft or up and down, measure free play on the opposite tip from where the stabilizer is moved by application of hand pressure. This eliminates errors in measuring due to bending deflections of the stabilizer itself.

If any or all of free play limits are exceeded, find which joint or joints seem to have most play and replace bushings until free play is within limits. In this connection, the up and down free play at the rudder root trailing edge is also affected by wear in the adjustable stabilizer trim system, particularly for the Model M-18L, where the 886 screwjack, located at the rear fuselage bulkhead, may exhibit excessive end play. In this case, either replace or rework the screwjack to eliminate the excessive end play.

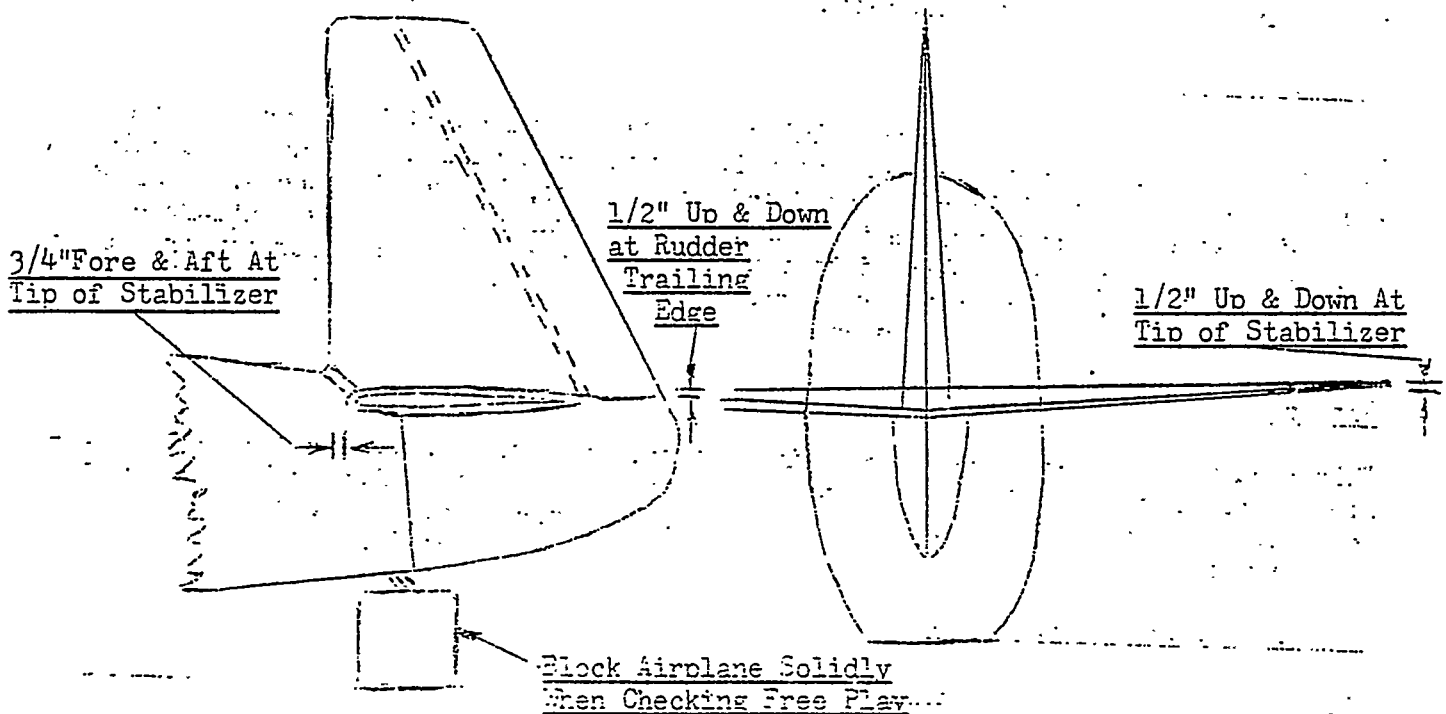
The following sketch illustrates the maximum allowable free play at the specified points.

When checking stabilizer tip free play, either fore and aft or up and down, measure free play on the opposite tip from where the stabilizer is moved by application of hand pressure. This eliminates errors in measuring due to bending deflections of the stabilizer itself.

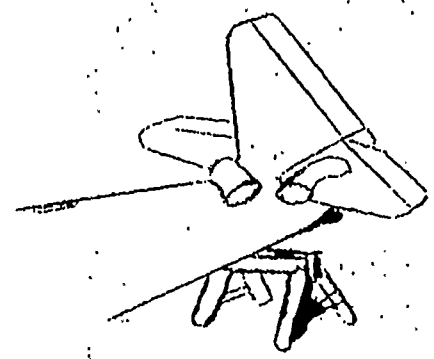
Elevate the aircraft on three suitable saw-horses. Two of which are placed under the wing just outboard of each main gear, between the third and fourth ribs, approximately three feet from the fuselage skin. The saw-horses should be of sufficient length to extend from slightly behind the rear spar to the front spar, and preferably past the leading edge of the wing. This length is desired to minimize damage to flaps and skin on the leading edge should the aircraft accidentally be rolled back or forward on the front spar while elevated on the horses. Should the tail be pushed down too far, a saw-horse extended behind the rear spar would rupture the flap fabric. Should the nose drop, rolling the aircraft onto the leading edge, the end of a saw-horse that did not extend beyond the spar would be pushed thru the leading edge skin. See Sketch A for elevation details.

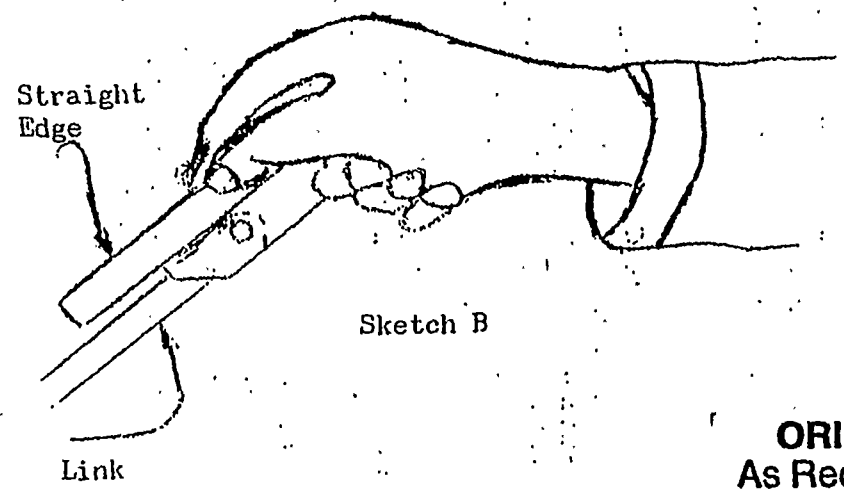
Sketch B

It has been found absolutely necessary for the over-center locks to be in the over-center position and that considerable force is required to change this position. To check whether lock is over center lay a short straight edge along the top side of the lock as shown in Sketch B.

When the straight edge and link are parallel the lock is over center. The locks are held in this position by the force required to place the retracting lever in the "Gear Down" position. On new airplanes or ones in which new parts are installed the force at the top of the lever with the main gears disconnected from the retracting truss on which the lever is mounted should be 18 to 24 lbs. The force should be 2 lbs. additional with all three gears connected. The nose gear should be checked alone first, on which greater or less force is controlled by adding or removing washers on the forward side of the handle lock down plate as shown in Sketch C.

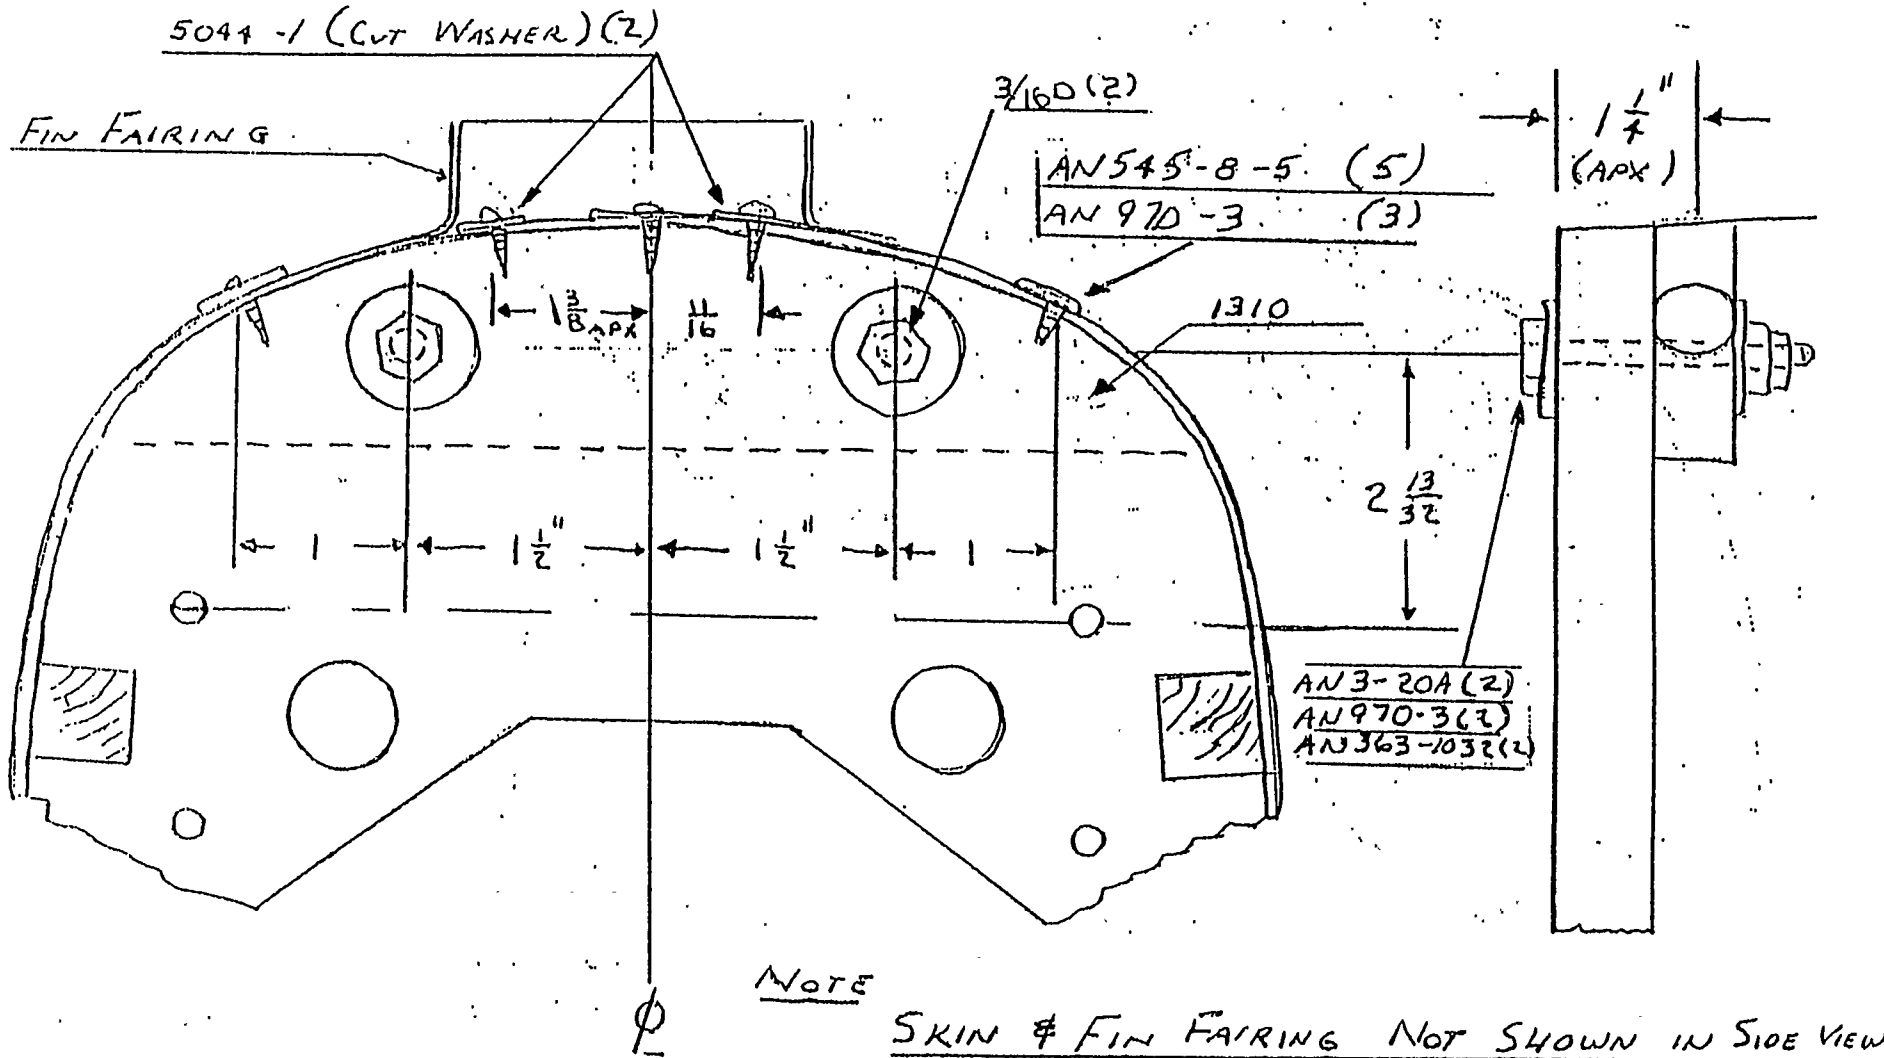
FIG. 1

Loose glue joint between bulkhead and tail cone skin at top of bulkhead.

1. All airplanes having the defect described in Item 1 of the Introduction are to be repaired in accordance with Figure 1 or Figure 2 depending on the type of elevator control system.
2. Order Rework Kit SL 18-17-1.
