Mooney Mite Series M-13
Service Bulletin No. 14

MOONEY AIRCRAFT, INC.
M-18 SERVICE LETTER NO. 15

M-18 SERVICE LETTER NO. 16

DATE: October 16, 1959
SUBJECT: General Inspection and Rework
MODELS AFFECTED: All M-18 Series Aircraft
TIME OF COMPLIANCE: Within the next 10 flight hours but not later than 11-15-59

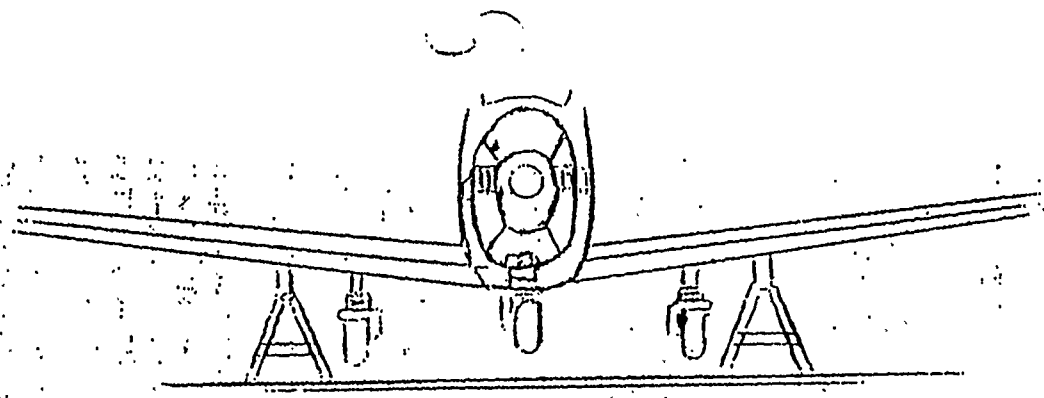
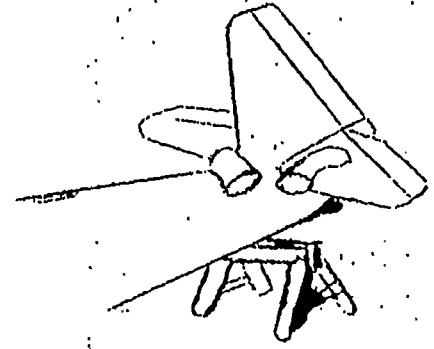
Elevate the aircraft on three suitable saw-horses. Two of which are placed under the wing just outboard of each main gear, between the third and fourth ribs, approximately three feet from the fuselage skin. The saw-horses should be of sufficient length to extend from slightly behind the rear spar to the front spar, and preferably past the leading edge of the wing. This length is desired to minimize damage to flaps and skin on the leading edge should the aircraft accidentally be rolled back or forward on the front spar while elevated on the horses. Should the tail be pushed down too far, a saw-horse extended behind the rear spar would rupture the flap fabric. Should the nose drop, rolling the aircraft onto the leading edge, the end of a saw-horse that did not extend beyond the spar would be pushed thru the leading edge skin. See Sketch A for elevation details.

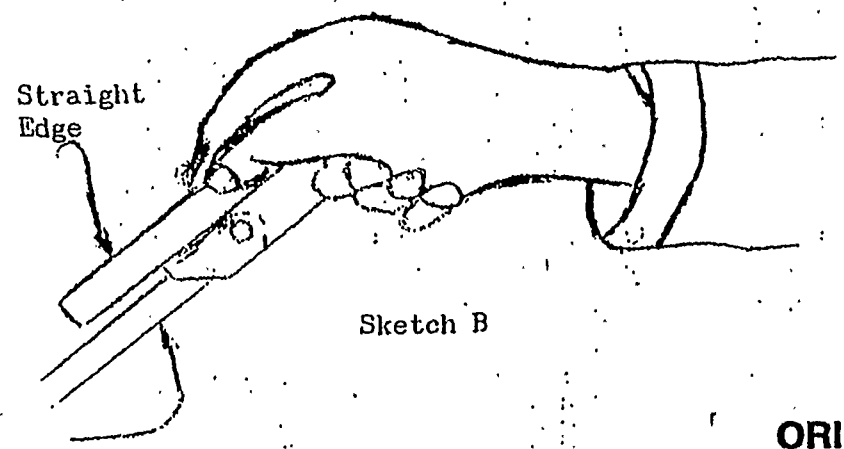
Sketch B

It has been found absolutely necessary for the over-center locks to be in the over-center position and that considerable force is required to change this position. To check whether lock is over center lay a short straight edge along the top side of the lock as shown in Sketch B.

When the straight edge and link are parallel the lock is over center. The locks are held in this position by the force required to place the retracting lever in the "Gear Down" position. On new airplanes or ones in which new parts are installed the force at the top of the lever with the main gears disconnected from the retracting truss on which the lever is mounted should be 18 to 24 lbs. The force should be 2 lbs. additional with all three gears connected. The nose gear should be checked alone first, on which greater or less force is controlled by adding or removing washers on the forward side of the handle lock down plate as shown in Sketch C.

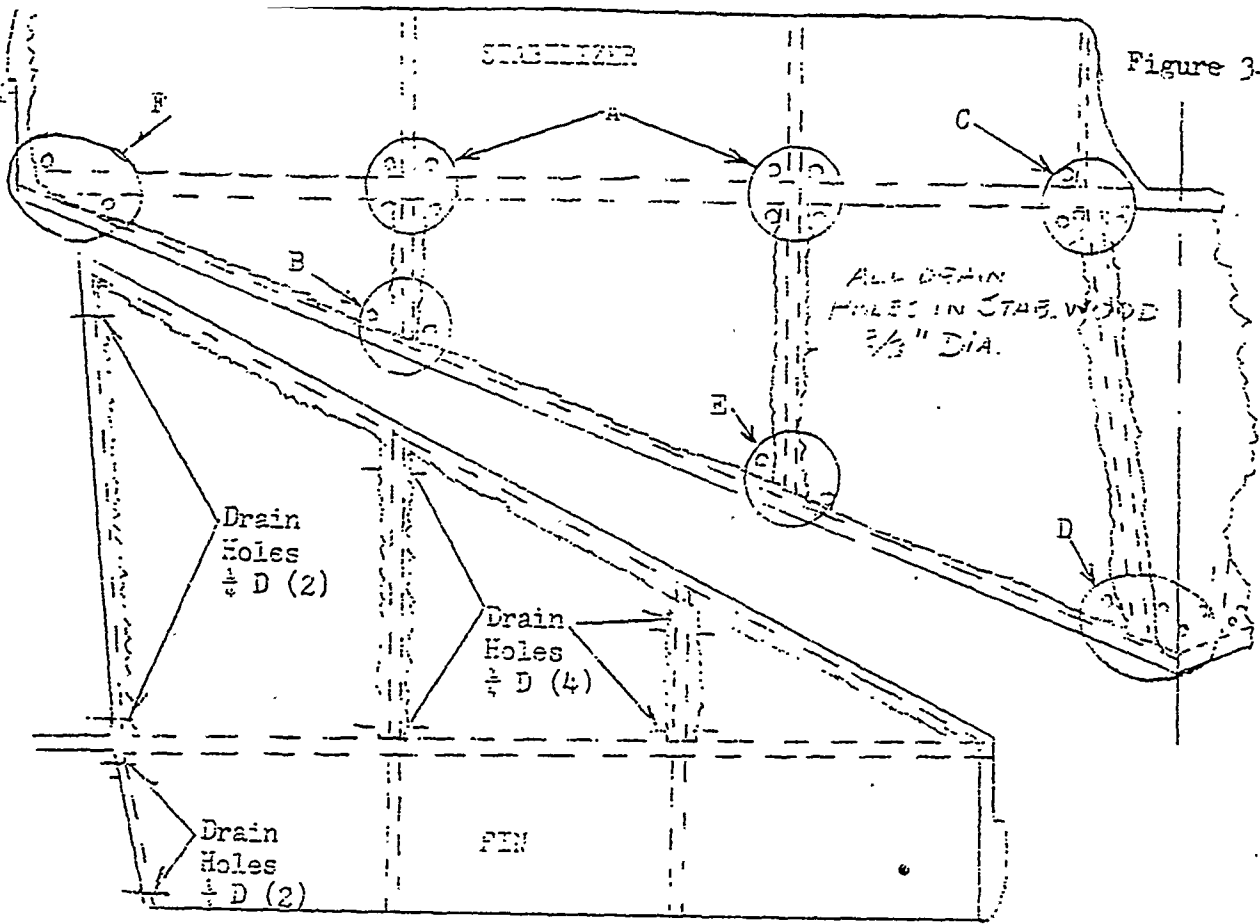
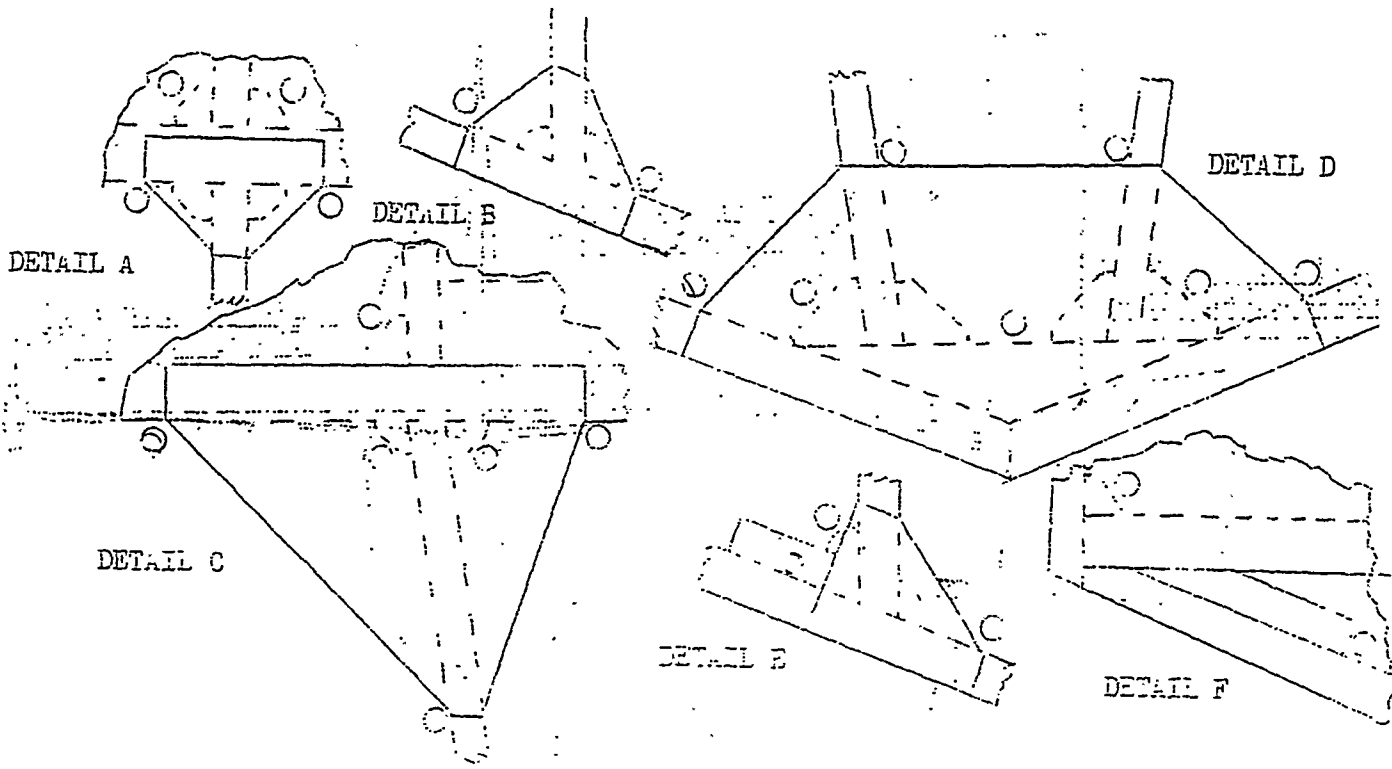
6. When recovering make fabric continuous under four outboard hinges on horizontal stabilizer and two upper hinges on fin. See that all drain holes are located as shown in Figure 3 and that they are clear.

- 1) Use all 331-B Grommets on Fabric over all drain holes in Stabilizer and Pin Body Kit.
- 2) Drill Pin Inlets in Ribs and clear hole in Body Kit after Fabric Installation.
- 3) Exercise care in drilling Drain Holes so as not to damage adjacent structure.

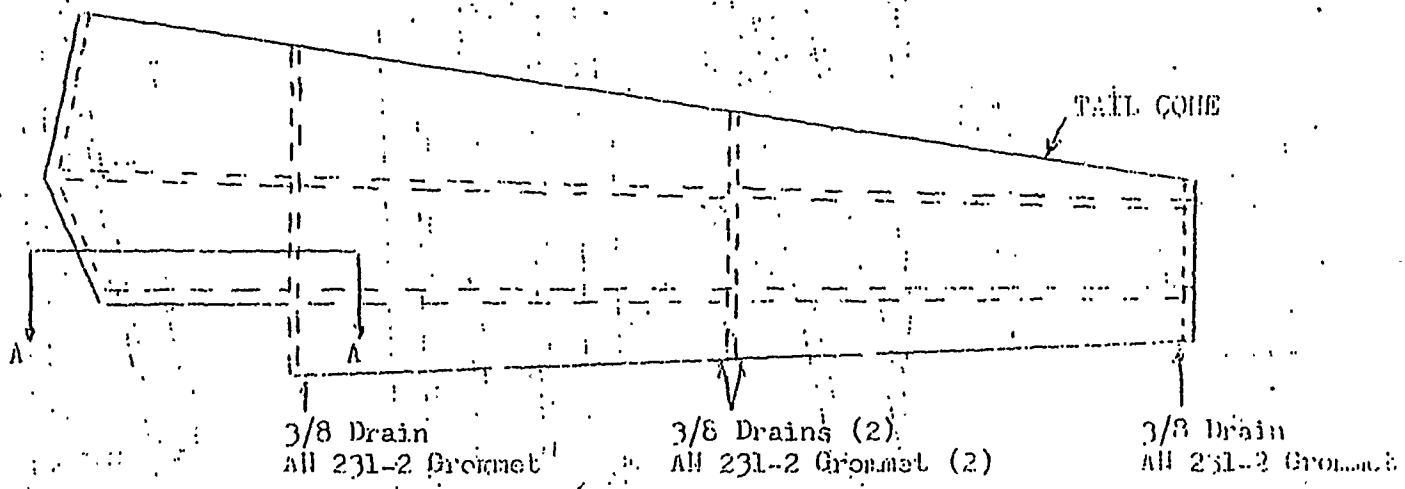
1. Inspect around steel fuselage fittings and drain holes for wood deterioration. See that all drain holes are located as shown in Figure 5 and that they are clear. Inspect all glue joints for deterioration.

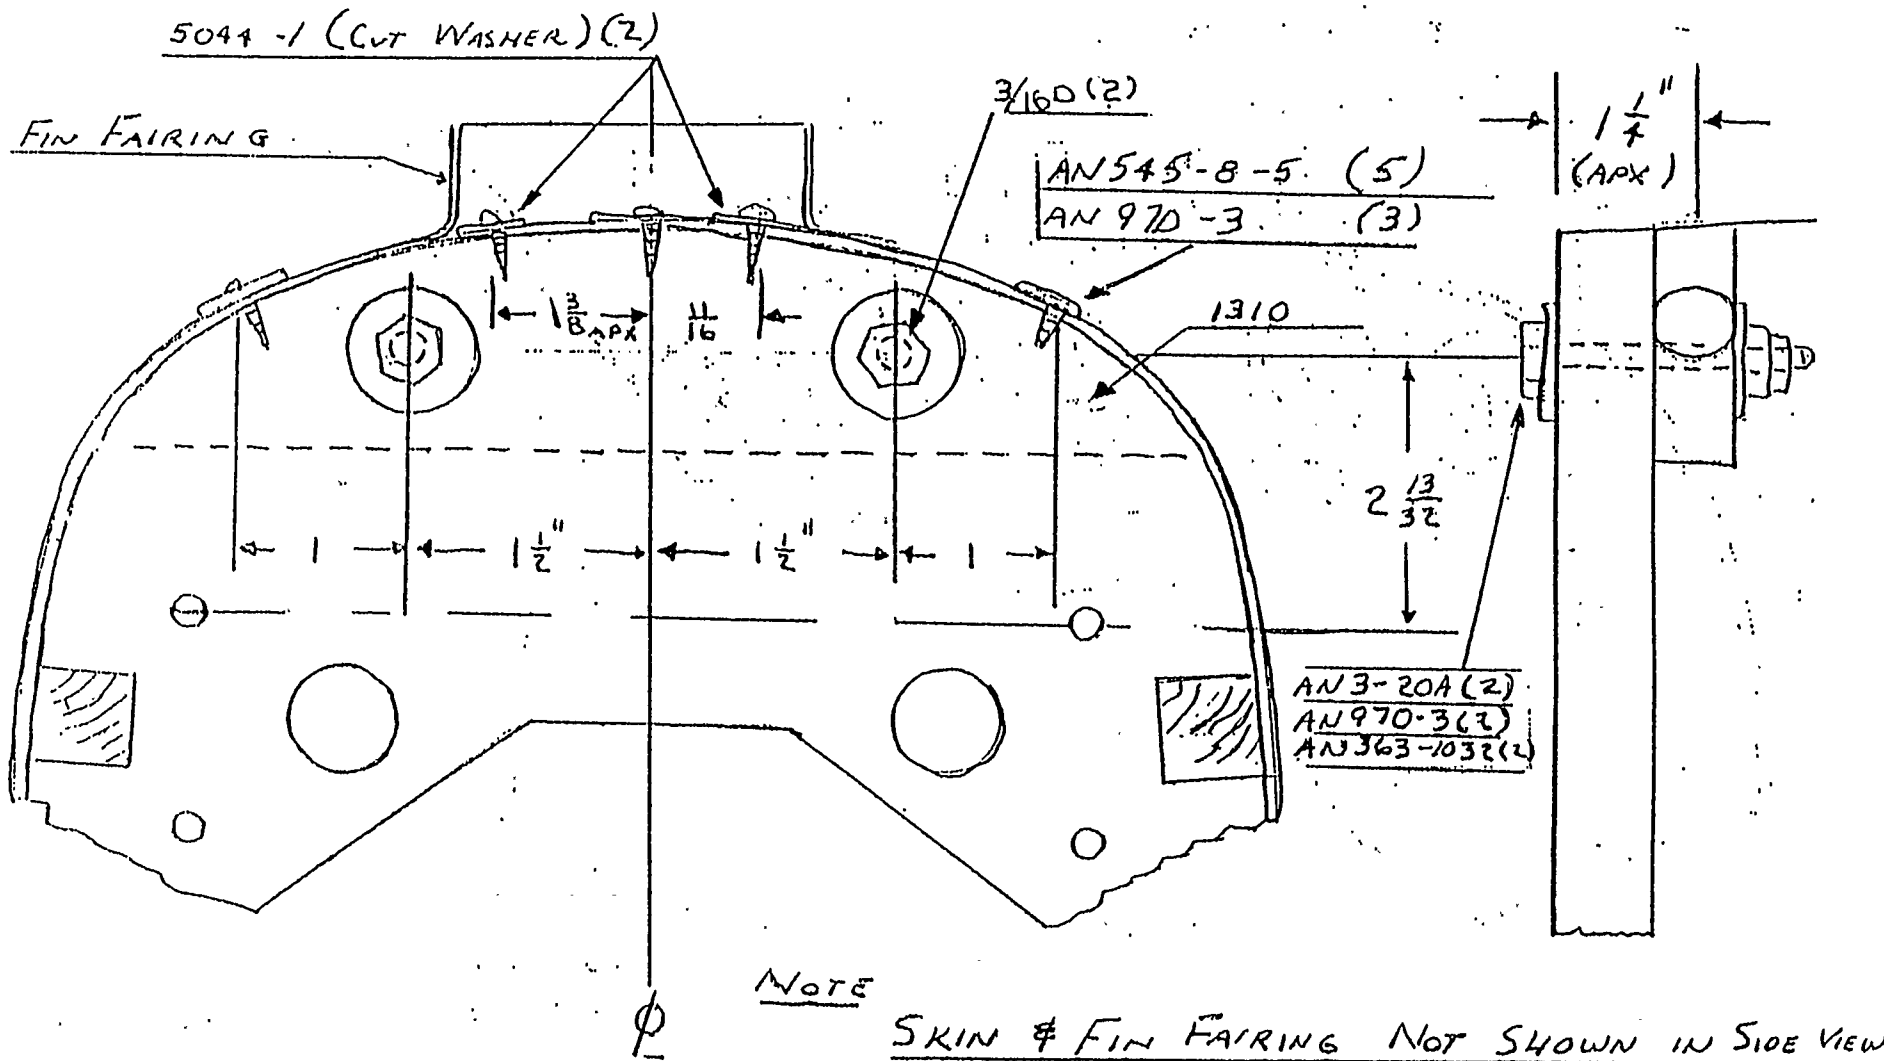
FIG. 1

Loose glue joint between bulkhead and tail cone skin at top of bulkhead.

1. All airplanes having the defect described in Item 1 of the Introduction are to be repaired in accordance with Figure 1 or Figure 2 depending on the type of elevator control system.
2. Order Rework Kit SL 18-17-1.
