**U.S. Department of Transportation
Federal Aviation Administration**

**Airworthiness Directive
Revision**

79-11-05 R1 MOONEY: Amendment 39-3480 as amended by Amendment 39-4050. Applies to Mooney M-18L S/N's 2 and up, M-18C S/N's 201 and up, M-18LA S/N's 100 through 200, M-18C55 S/N's 323 and up certificated in all categories.

Mooney Mite Model 18

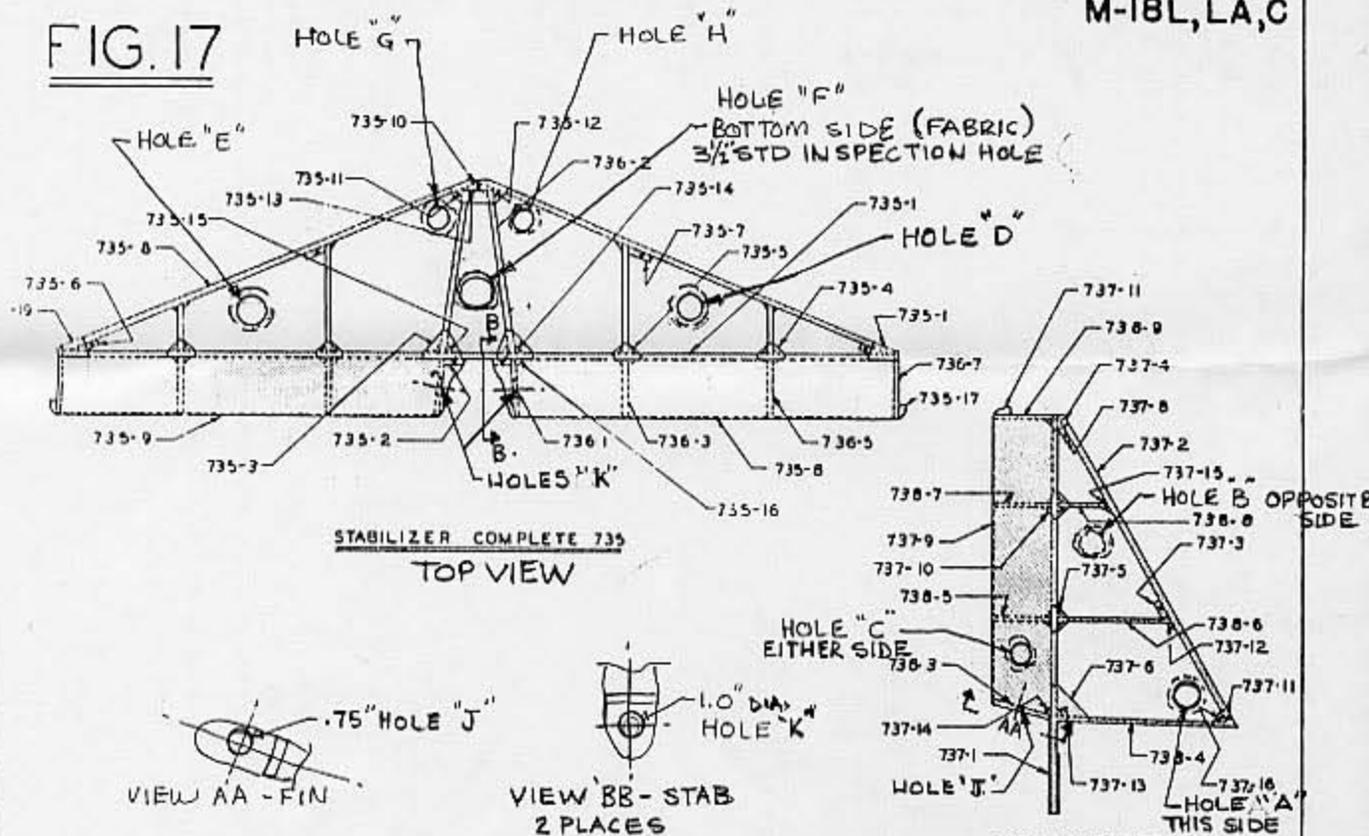
FIG. 17

- A. The following modifications are acceptable as an alternate method of inspection compliance for using a borescope with Paragraphs (1), (2) & (3) of AD79-11-05R1 dated 27 Feb 1981. SEE:

- (e) Follow the procedures (b) through (d) above for holes "A" through "H", except for hole "F". All holes in stabilizer are located on bottom side only.

- (f) The holes shown in view AA and BB should remain open. If hole "K" is to be used for inspection purposes, hole "C" is not required or vice versa; it's optional.

- (g) NOTE: Hole "F" is already an existing inspection hole in the bottom side of stabilizer.
- (h) Holes in fin are placed on either side or as noted on the drawing.

- (a) Cut 2.00 inch diameter holes in approximately the locations as shown on stab & fin drawing.
- (b) Cut a 2.62 inch diameter plastic ring with a 2.00 inch diameter hole from a .025 inch thickness material.

- C. In order to accomplish the stab & fin modifications of inspection holes to accommodate the AD note, the stab & fin assembly should be removed from the fuselage. In addition, it is best to disassemble the stab & fin for access to cut certain inspection holes for inspection of possible spar cracks and wood deterioration.

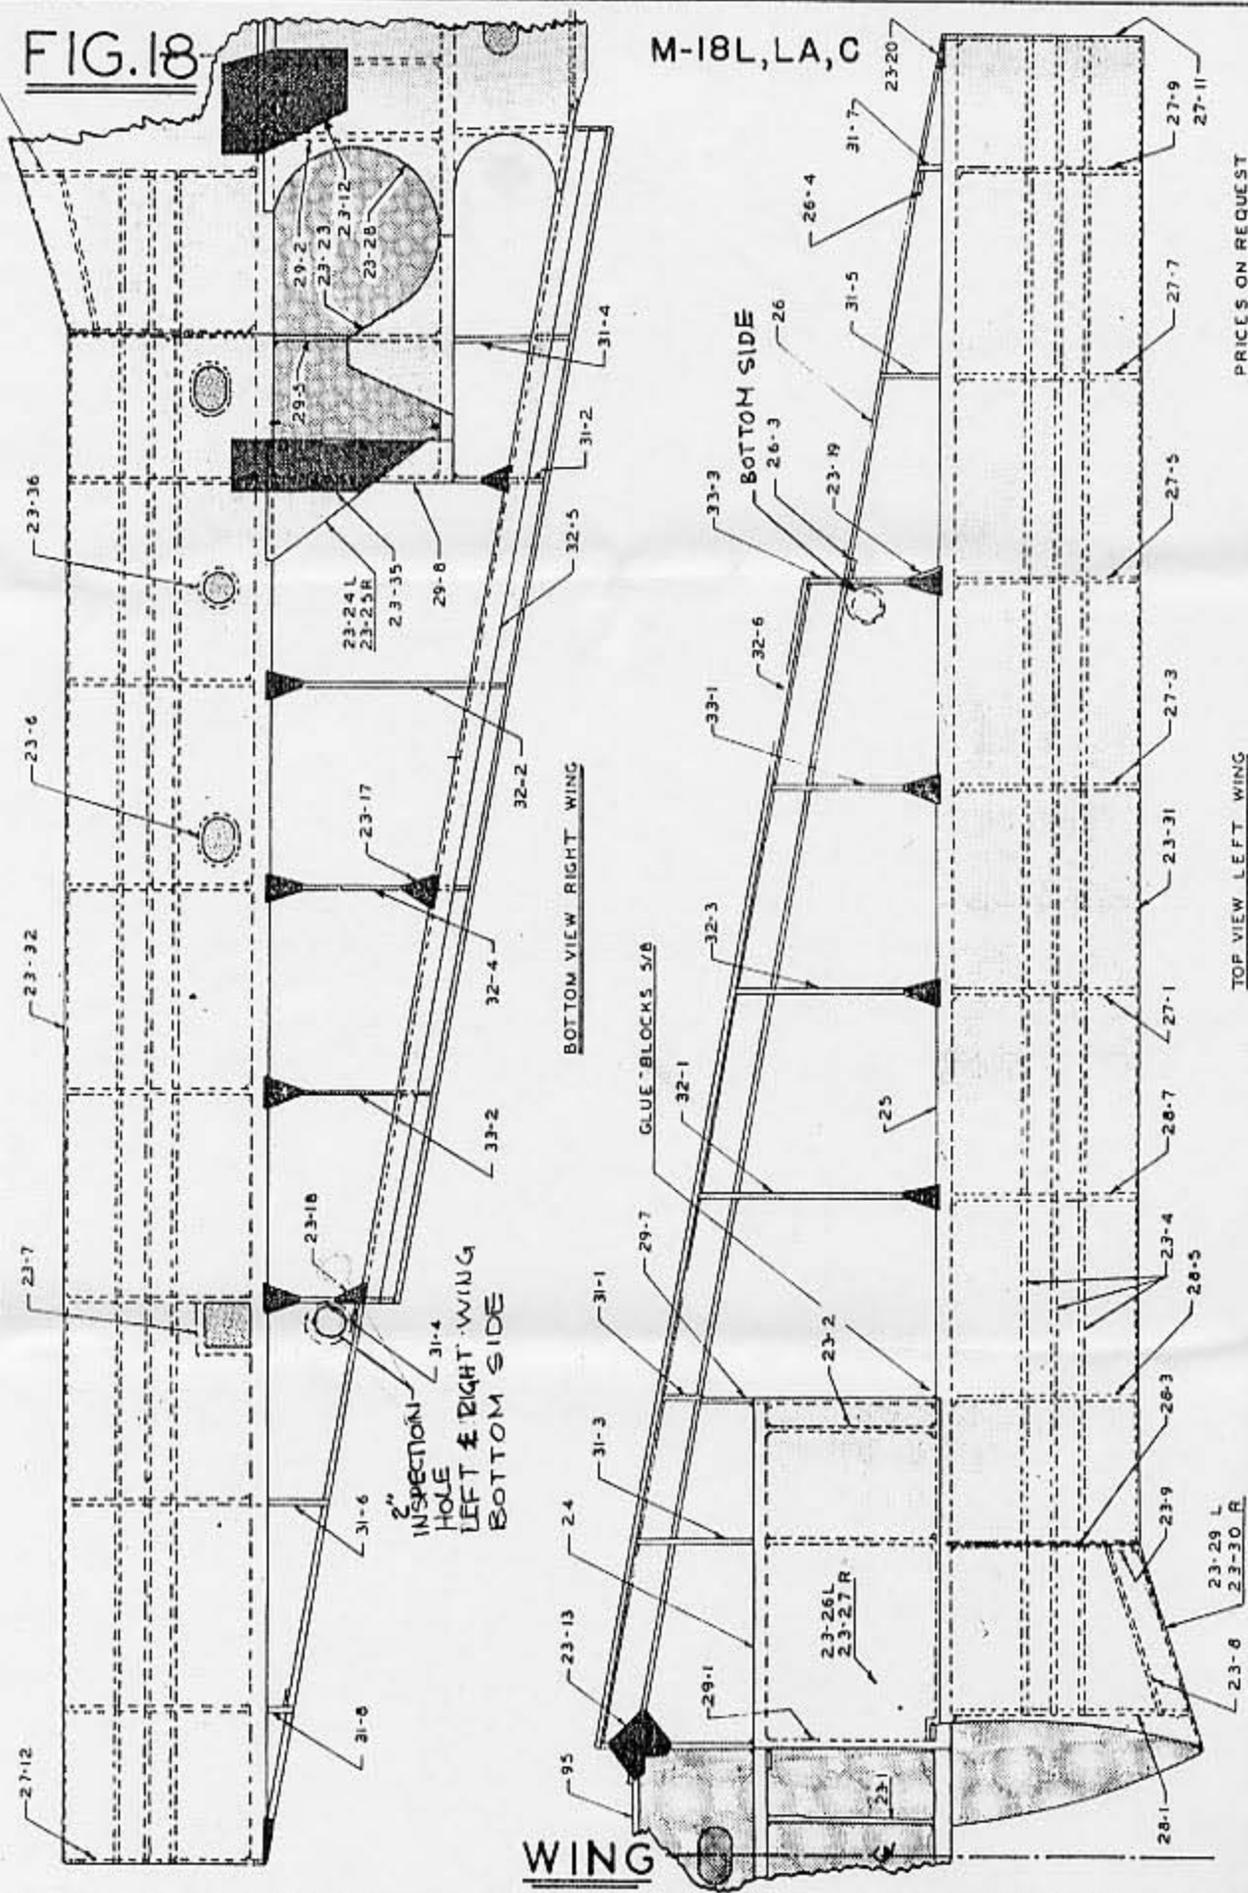
FIG. 18

- B. The following method is an optional method of access in inspection compliance for Paragraph (4) of AD79-11-05 R1 dated 27 Feb 1951. SEE:

- (a) Cut 2.00 inch diameter holes in approximately the locations shown on the bottom side of the wing drawing.
- (b) Cut a 2.62 inch diameter plastic ring with a 2.00 inch diameter hole from a .025 inch thickness material.
- (c) Follow the same procedures (c) and (d) described for FIGURE17 stab & fin to complete the process.
