Mooney Mite Series M-13
Service Bulletin No. 14

MOONEY AIRCRAFT, INC.
M-18 SERVICE LETTER NO. 15

M-18 SERVICE LETTER NO. 16

DATE: October 16, 1959
SUBJECT: General Inspection and Rework
MODELS AFFECTED: All M-18 Series Aircraft
TIME OF COMPLIANCE: Within the next 10 flight hours but not later than 11-15-59

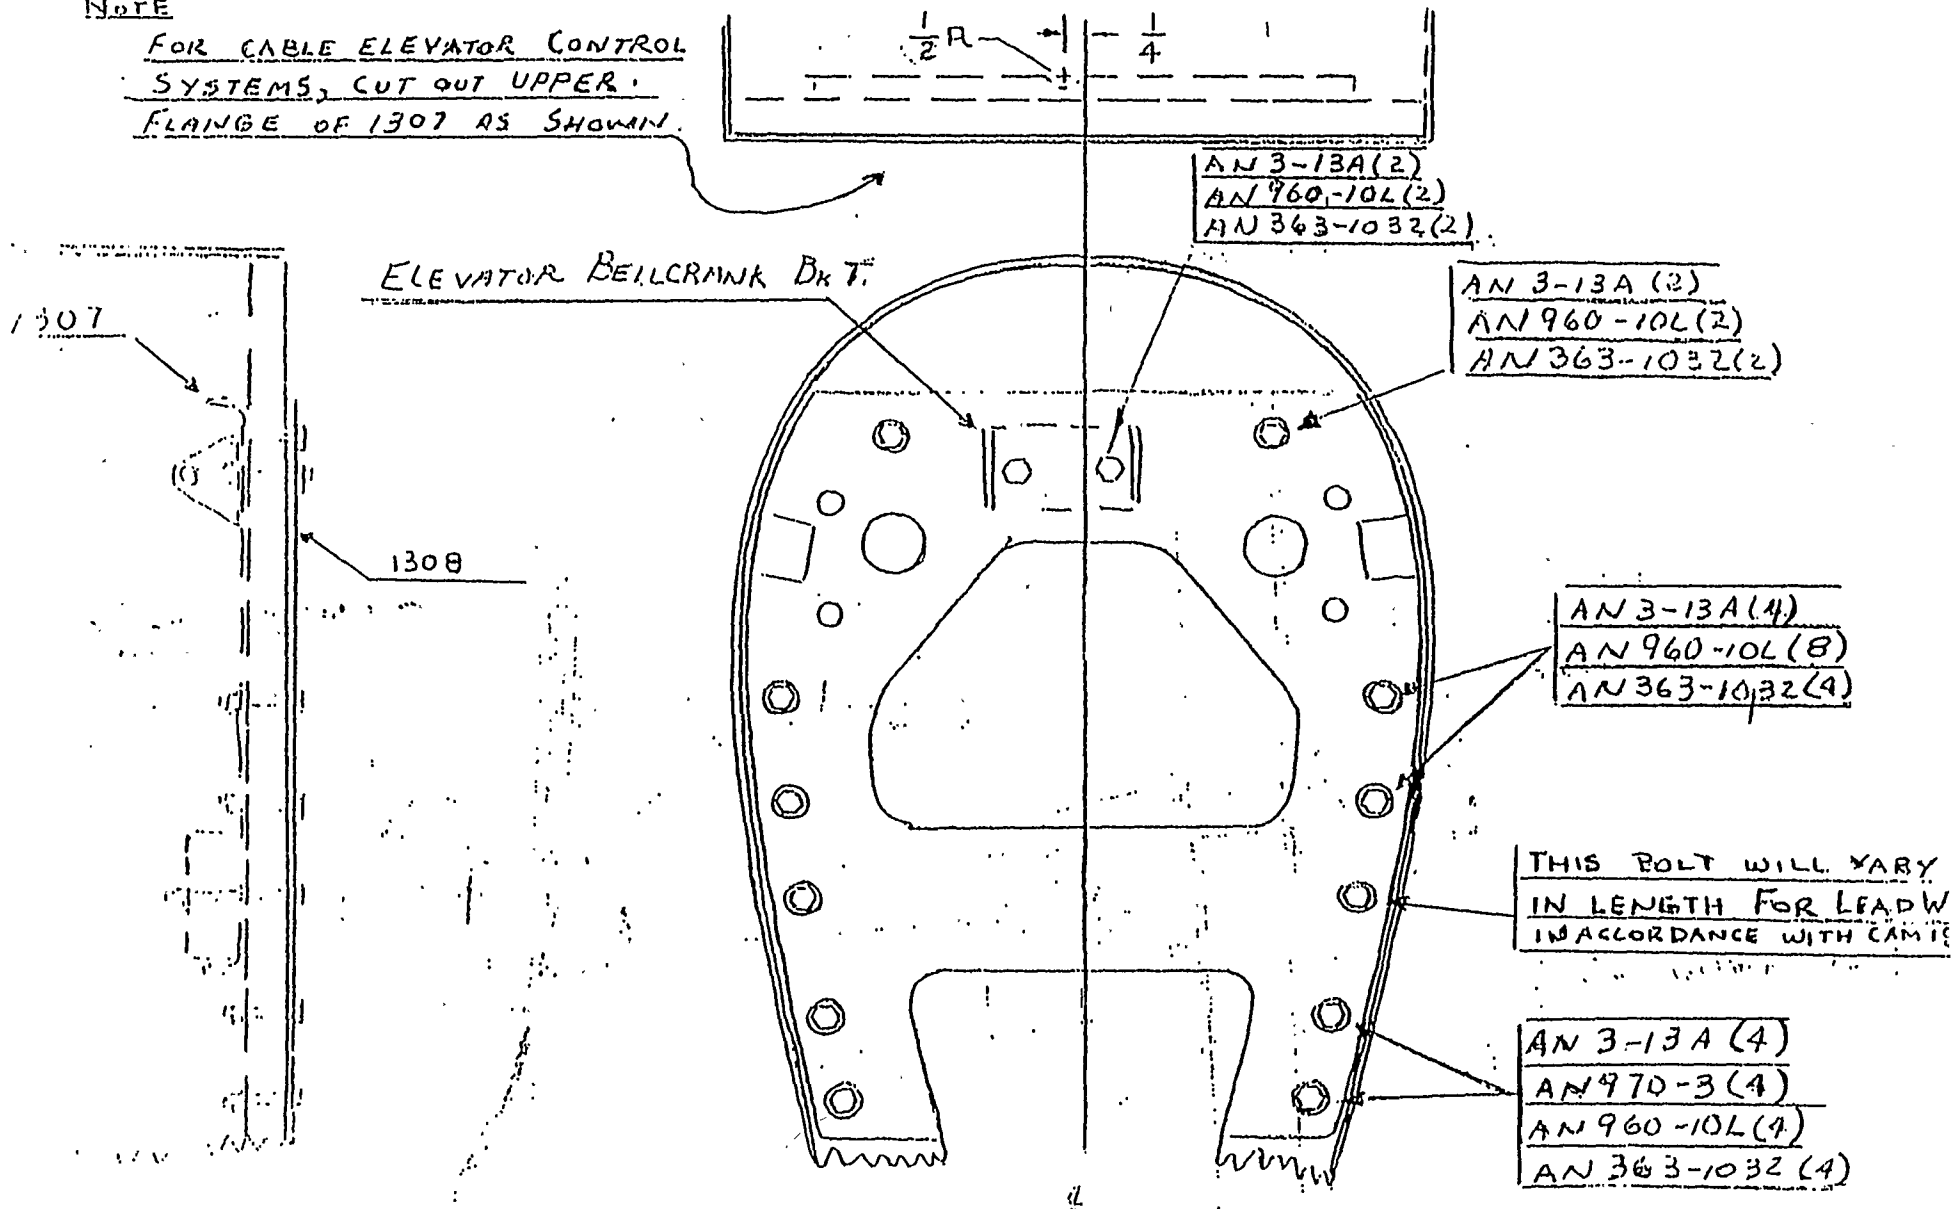
FIG. 3

Reports involving M-18 aircraft manufactured prior to 1953 have been received concerning the following defects in the rear-most bulkhead.

Loose glue joint between bulkhead and tail cone skin at top of bulkhead.

- 2) Separation of plywood web and spruce core.
- 3) Cracks of plywood web and/or spruce core in the area of the empennage attachment brackets.

- a. Remove the following items from bulkhead:
 - i. Elevator bellcrank bracket
 - ii. Lead ballast weight if installed
 - iii. Longeron clips P/N 1157-1/-2 (if installed) by removing bolt through upper longeron
- b. Clean excess paint or glue off faces of bulkhead so that plates bear on flat surface.
- c. Attach P/N 1307 and 1308 plates to bulkhead using AN3 bolts through the tail attachment holes, elevator bellcrank bracket and holes, and lead ballast and holes. NOTICE - Do not reassemble tail attachment brackets at this stage.
- d. Using P/N 1308 as template drill 3/16 diameter holes (10) through bulkhead and P/N 1307. Exercise care to drill holes perpendicular to bulkhead. Install AN3 bolts specified in Figure 3 for attachment of elevator bellcrank bracket, lead ballast, and through holes drilled. Exercise care in tightening bolts so as not to crush bulkhead.

FOR CABLE ELEVATOR CONTROL SYSTEMS, CUT OUT UPPER FLANGE OF 1307 AS SHOWN.
